PROPERTY INSPECTION REPORT

Sample Way, Orlando, FL 32803

DATE OF INSPECTION: 7/7/2019

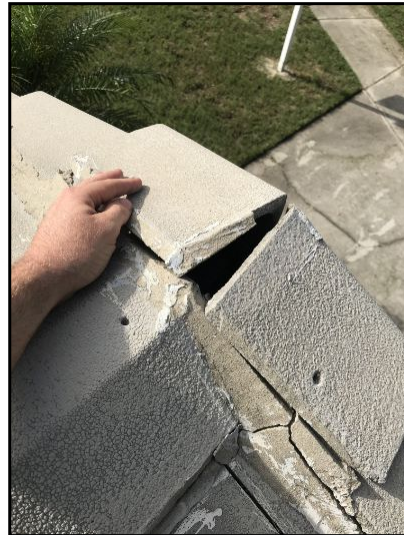
Cap tiles need to be re-mortared

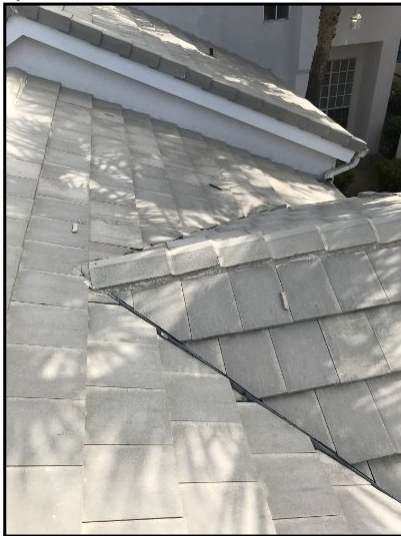
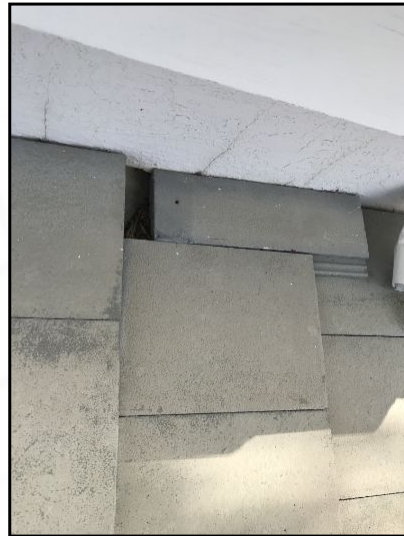
Loose rake tiles

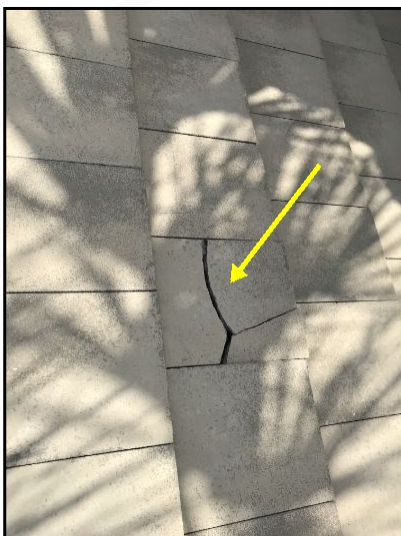
Slipped tile. This is in the area that has the leak above the garage. I doubt this is the main cause of the leak. Most likely there is damage to the flashing underneath.

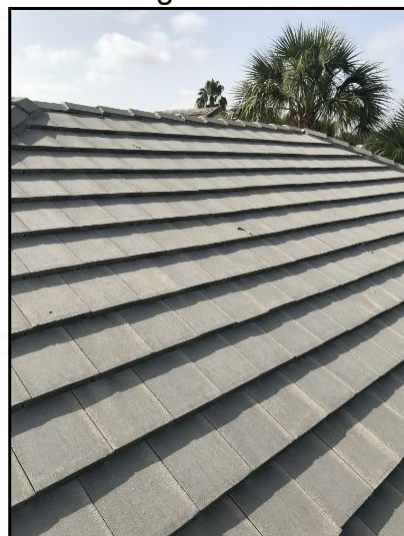
- The roof had cracked and/or broken concrete roof tiles that should be replaced to help prevent damage from moisture intrusion to the home materials, the roof structure and to prevent development of microbial growth such as mold. The Inspector recommends that before the expiration of your Inspection Objection Deadline you consult with a qualified contractor to discuss options and costs for repairs.
- Tiles along the rakes (sloped roof edges) were loose and fasteners were visibly protruding. Falling tiles can cause serious or fatal injury. The inspector recommends correction by a qualified roofing contractor.

Broken tile

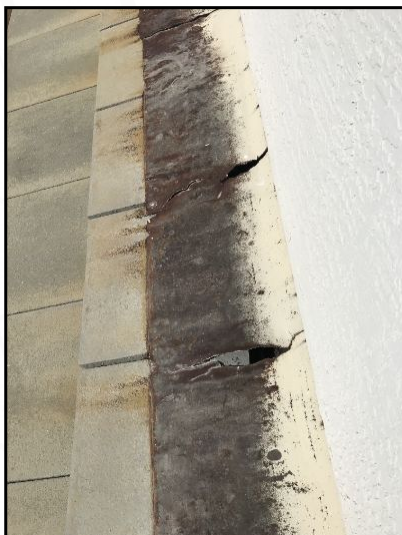
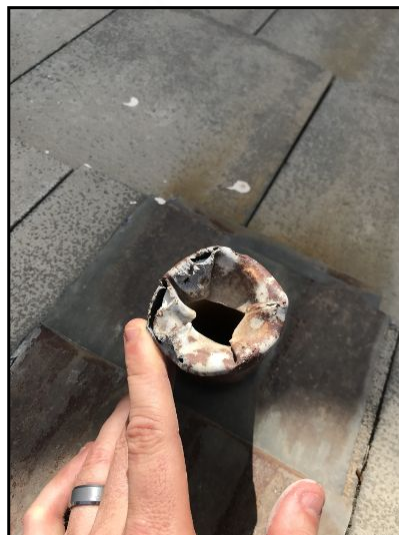
- Headwall flashing exhibited general severe corrosion and was rusted through in places. This condition is likely to allow roof leakage. Headwall flashing in this condition should be replaced immediately to avoid damage from roof leakage. The Inspector recommends that before the expiration of your Inspection Objection Deadline, you consult with a qualified roofing contractor to discuss options and costs for replacement.

Flashing that has rusted through. This needs to be replaced or sealed up.

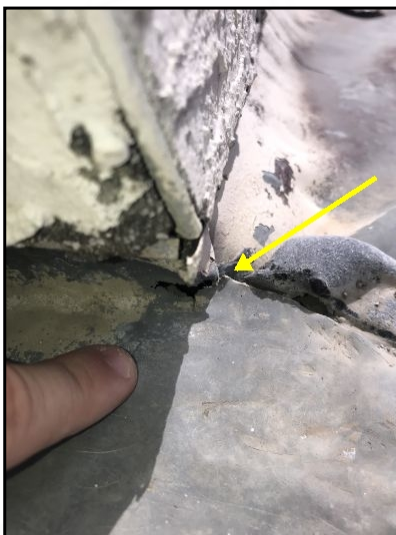
Chimney flashing has areas of corrosion. These holes may be what's causing the leak.

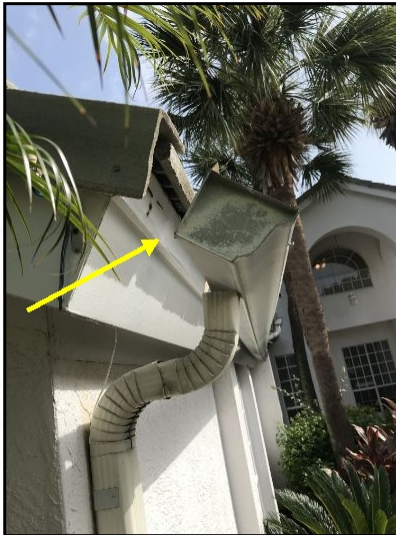
One or more gutter sections needed to be re-connected in order to properly control roof run-off. The Inspector recommends that work be performed by a qualified contractor.

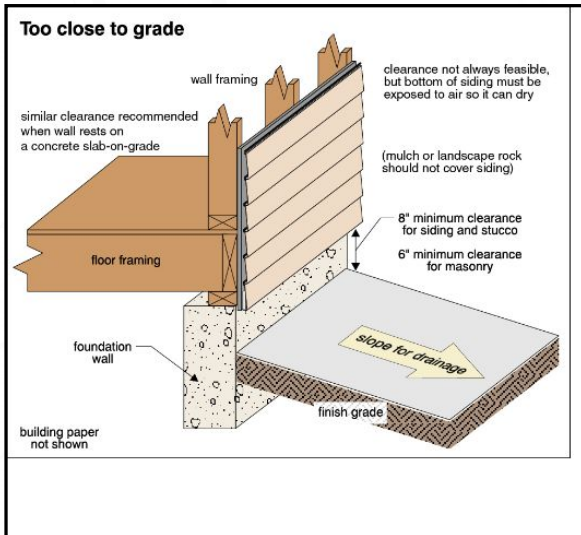
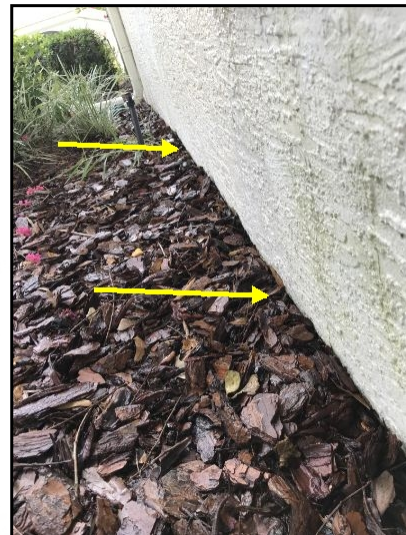
- Stucco covering exterior walls of the home had inadequate clearance from grade. Stucco should terminate a minimum of 4 inches above grade. This condition may result in staining and deterioration of the lower portion of the wall stucco from moisture absorption.
- The inspector noted minor cracks in the stucco over wood frame. Being that this area is wood framed, the inspector recommends to have these cracks sealed and painted whenever they occur to keep moisture out. All work should be performed by a licensed technician.
- [Maintenance tip]-Stucco is a durable material that can last decades if maintained well. We recommend painting stucco every 5-10 years in Florida

Push mulch back away from the siding.

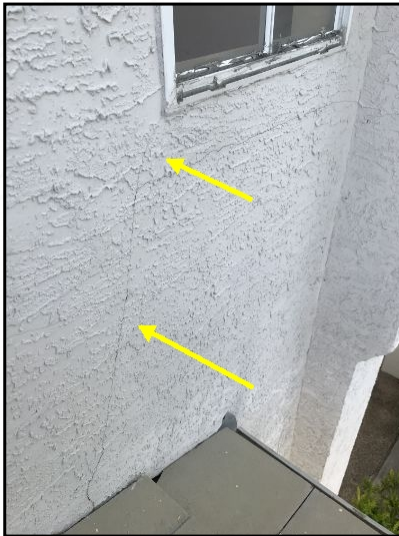
The inspector noted minor cracks in the stucco over wood frame. Being that this area is wood framed, the inspector recommends to have these cracks sealed and painted whenever they occur to keep moisture out. All work should be performed by a licensed technician

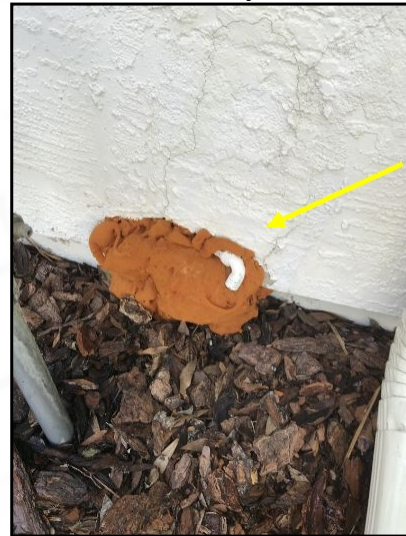
Unprofessional repair. Expanding foam will decay in sunlight. Recommend having a licensed professional repair this area

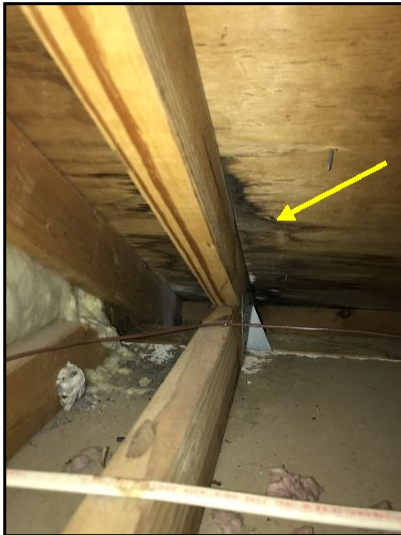
- The inspector observed discoloration on roof sheathing in the attic. Testing with a moisture meter revealed elevated moisture levels indicating active roof leakage. The source of the leak should be identified and corrected by a qualified roofing contractor.

Active leak above the garage

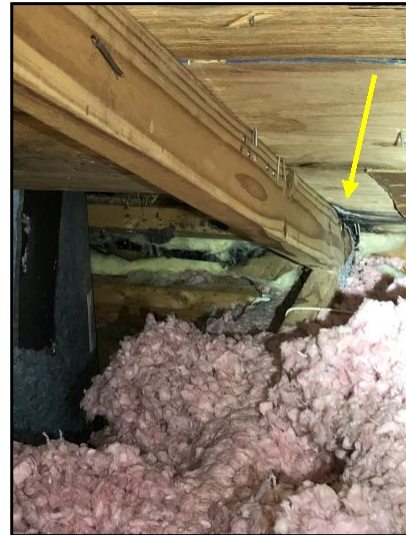
Stains around the chimney. I could not test this with a meter but the ceiling below was wet in the upstairs bathroom.

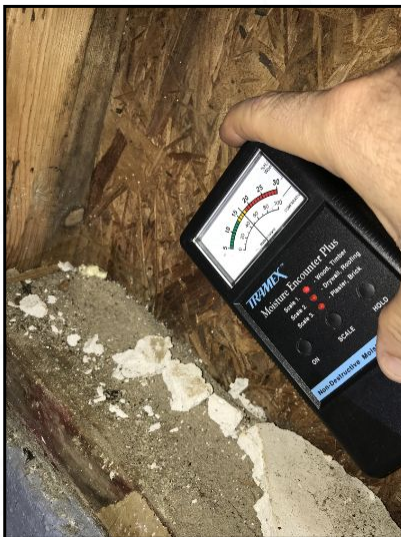
- The garage walls had severe damage visible at the time of the inspection. The Inspector recommends that before the expiration of your Inspection Objection Deadline you consult with a qualified contractor to discuss options and costs for repair.
- Stains on the garage walls indicated moisture intrusion. The moisture meter showed elevated levels of moisture in the wall materials at the time of the inspection, indicating that intrusion has been recent. The source of moisture should be identified and the condition corrected to avoid damage to the home structure and materials and the development of conditions that may encourage microbial growth such as mold.

Moisture meter detected the wall next to the water heater was wet. This may be from the siding being in contact with the soil and absorbing the moisture.

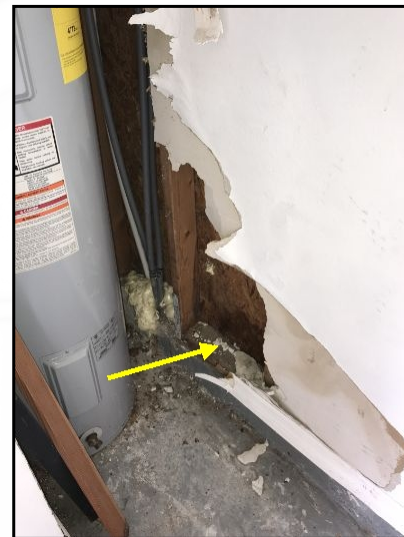
Wet area

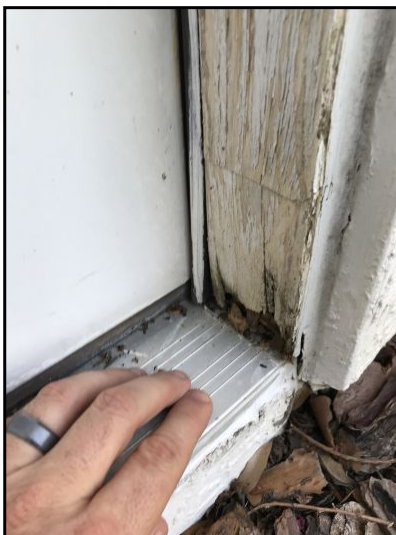
Wood decay around the exterior garage door

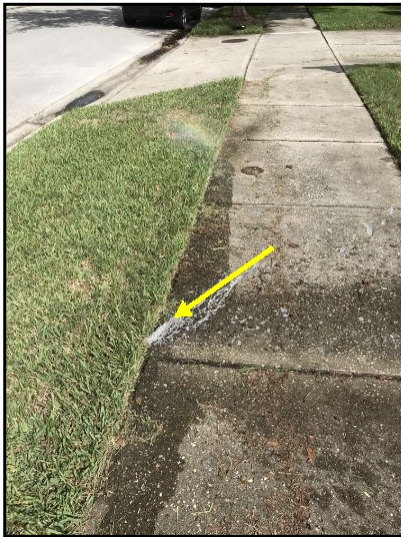
- The inspector noted a few broken sprinkler heads. These should be replaced to avoid wasting water. All work should be performed by a qualified contractor.

Broken head

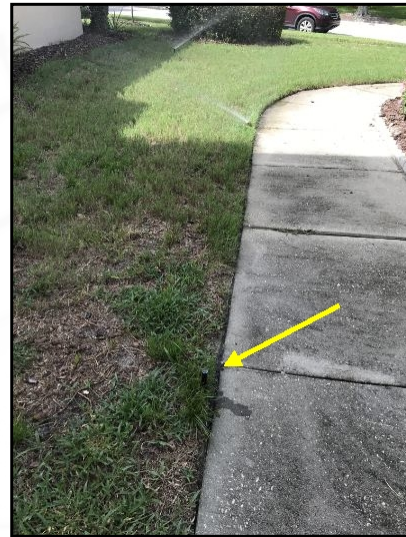
Inoperable head

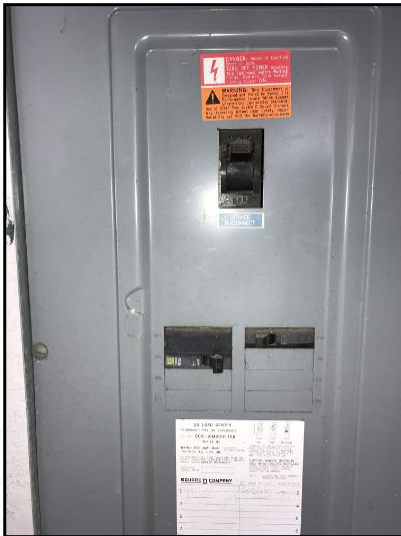
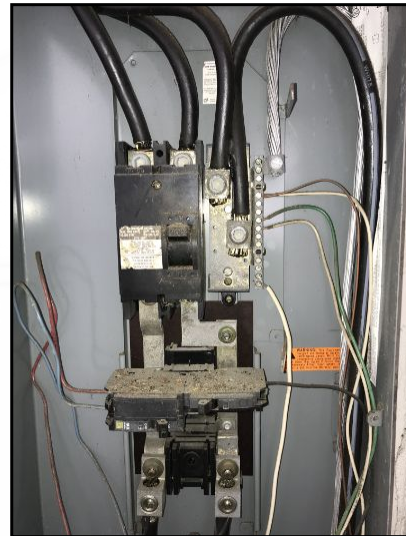
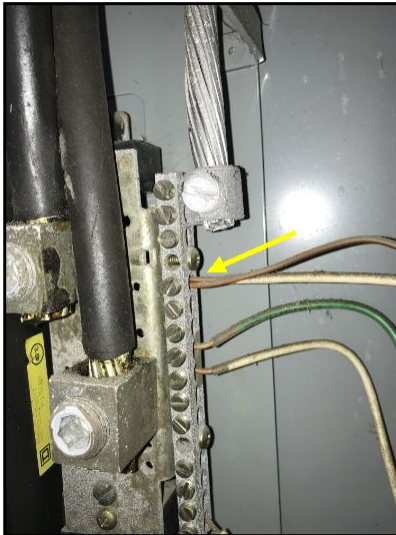
- In the service panel, there were two wires connected to a lug that only accepts 1 wire. This is a defective condition that should be corrected. Recommend repair by a licensed electrician.

Double lugged neutral

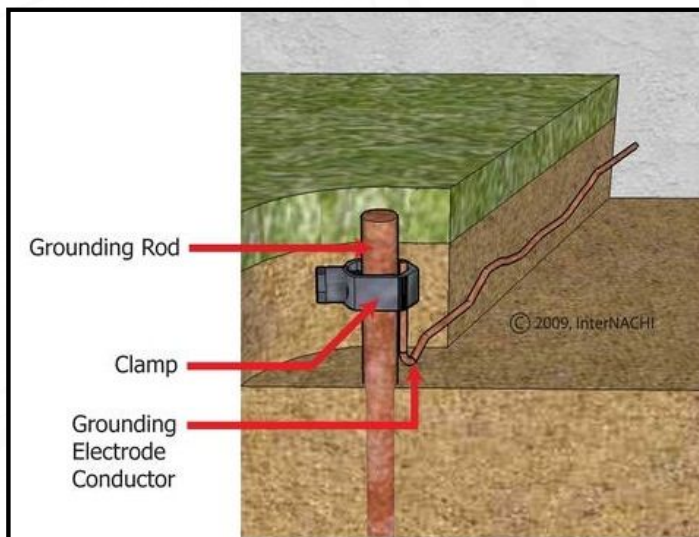
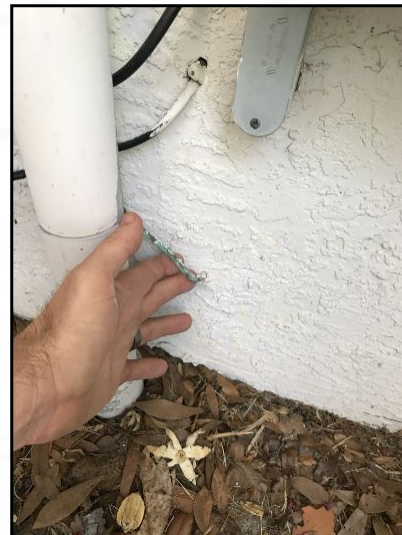
- The service panel had a grounding electrode conductor (GEC) visible that was bonded to the service cabinet and exited the cabinet, disappearing into soil near the panel. The Inspector was unable to confirm proper connection to a grounding electrode. This condition is common because grounding electrodes are required by modern safety standards to be fully buried. Confirmation of proper, effective service grounding would require special instruments and the services of a qualified electrical contractor.

Ground wire has been cut off from the ground rod.

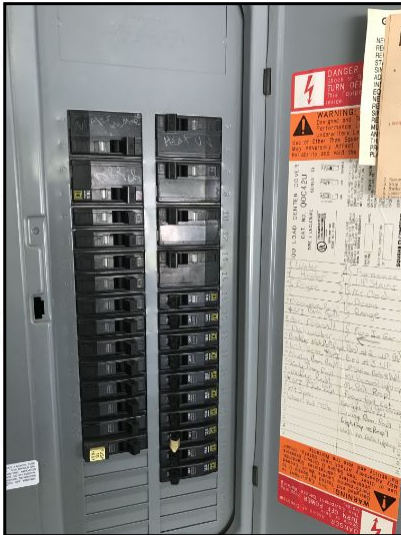
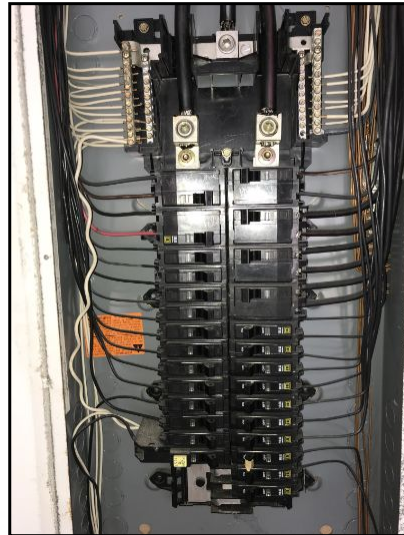
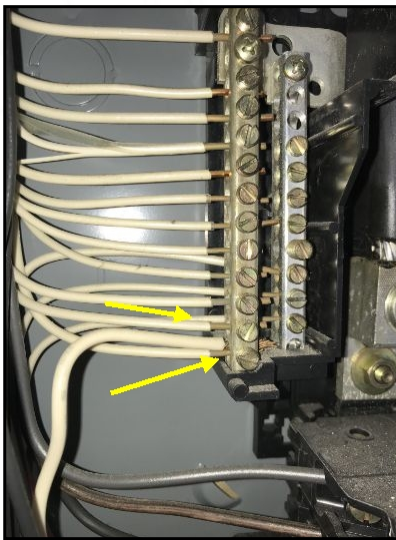
Page 21 Item: 3	Sub-Panel	<ul style="list-style-type: none"> In this electrical panel, two wires were connected to a screw designed for only one wire. This is a defective condition that should be corrected by a qualified electrical contractor.
Plumbing

- In this electrical panel, two wires were connected to a screw designed for only one wire. This is a defective condition that should be corrected by a qualified electrical contractor.

Double lugged neutrals

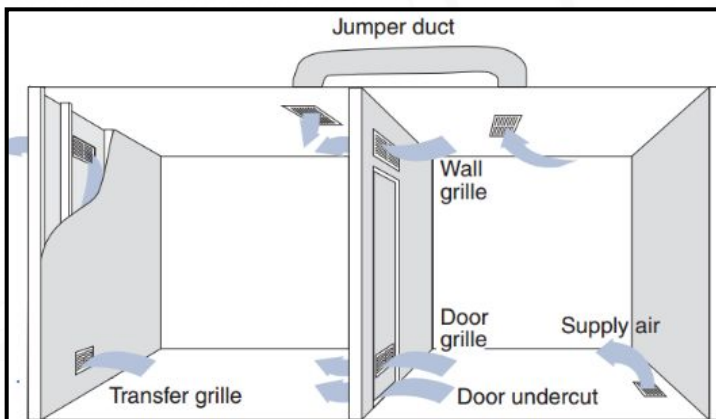
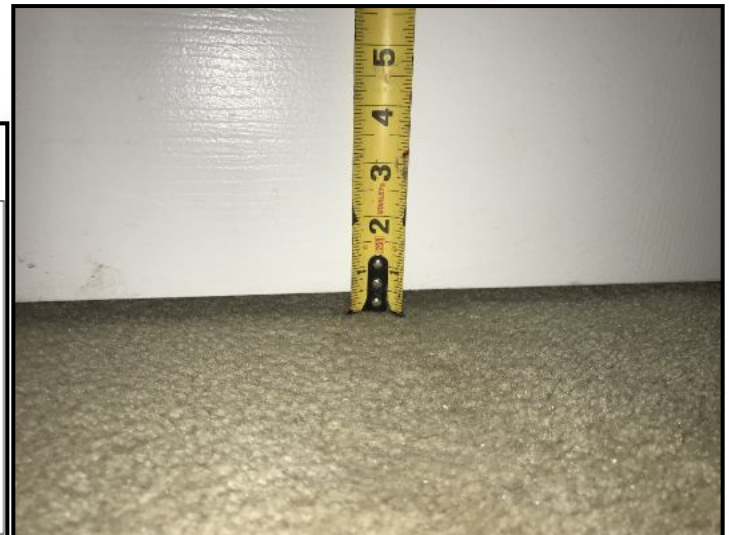
- In some rooms, return air registers were not located in the same room as supply registers and the gap beneath the door leading to the area in which the return air register was located had less than the recommended minimum 1-inch gap. Door bottoms in rooms where this condition exists should be trimmed in order to maintain adequate air circulation and heating system performance. All work should be performed by a qualified contractor.

The bedroom doors do not have a large enough gap for proper return air. This will make the rooms get warm when the doors are closed. You can have some more material cut off the bottom of the door or you can add transfer grills above the doors to correct this

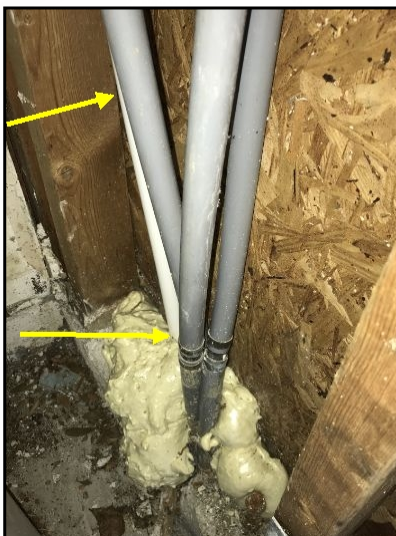
While scientific evidence is scarce, it is believed that oxidants in the public water supplies, such as chlorine, react with the polybutylene piping and acetyl fittings, causing them to scale, flake and become brittle. Micro-fractures result, and the structural integrity of the water distribution system is compromised. The system may become weak and fail without warning causing damage to the building structure and personal property.

Polybutylene pipe

The Inspector recommends evaluation of the water distribution pipes by a qualified plumbing contractor.

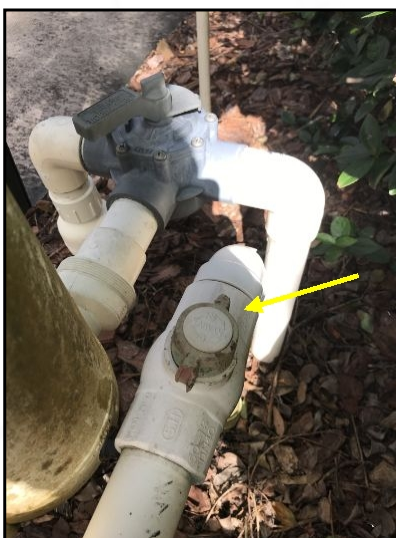
- The inspector noted that one or more knobs for the control valves was damaged or missing. Recommend repair

Broken control valve handle

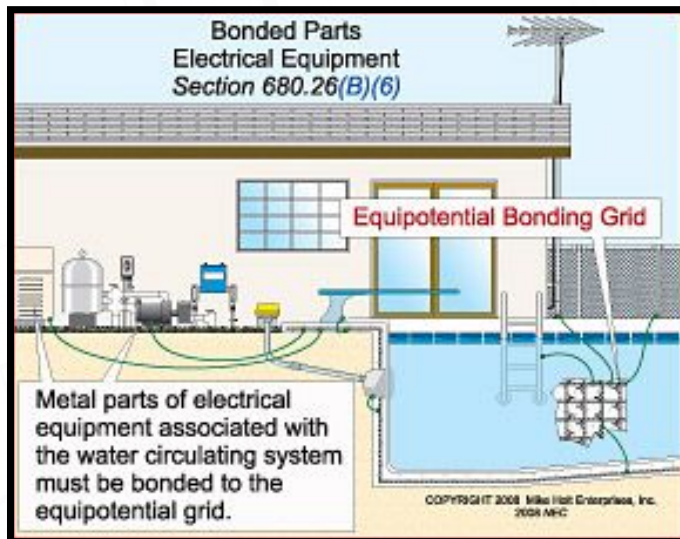
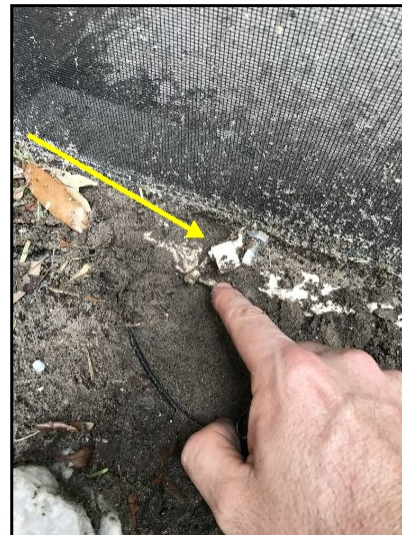
- Some pool components were lacking or were not connected to the bonding system. This condition is a potential shock/electrocution hazards and should be corrected by a qualified contractor.

The pool enclosure is not connected to the bonding grid.

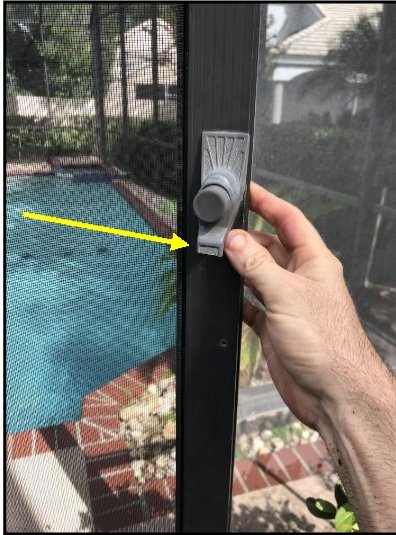
- The inspector noted that the screen door hardware was damaged. Recommend repair by a licensed technician.

Broken handle

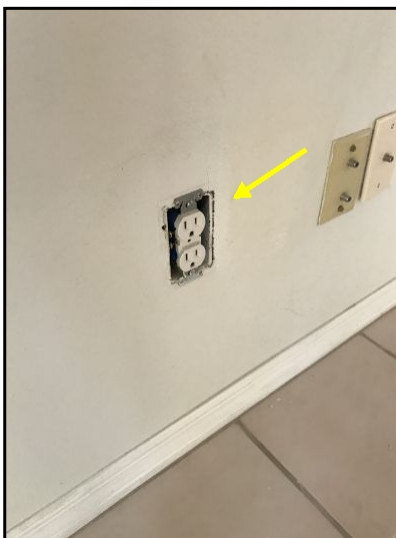
- A few receptacles were missing a cover plate. This condition left energized electrical components exposed to touch. This shock/electrocution hazard should be corrected by a qualified electrical contractor.

Missing cover plate in the living room

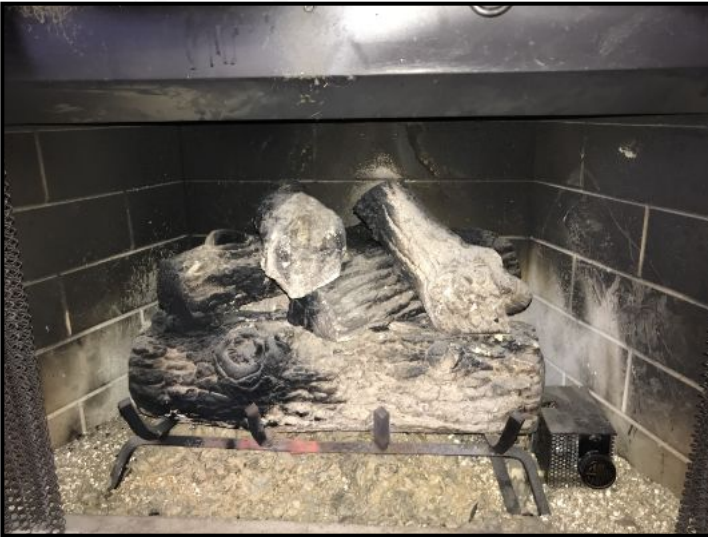
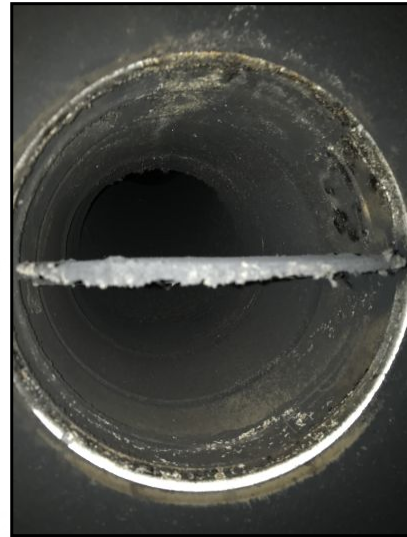
• The gas fireplace did not respond to the controls. It may be inoperable or it may be turned off at the primary controls. For a full inspection to more accurately determine the condition of the fireplace and to ensure that safe conditions exist, the Inspector recommends that you have the fireplace inspected by an inspector certified by the Chimney Safety Institute of America (CSIA).

Could not test the fireplace due to the tanks being empty

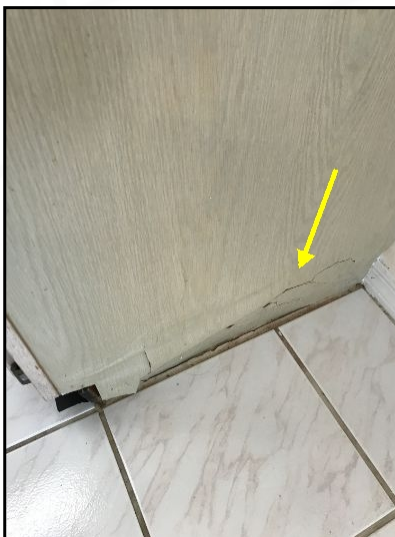
- The kitchen cabinets had minor damage.

Damage to the cabinet

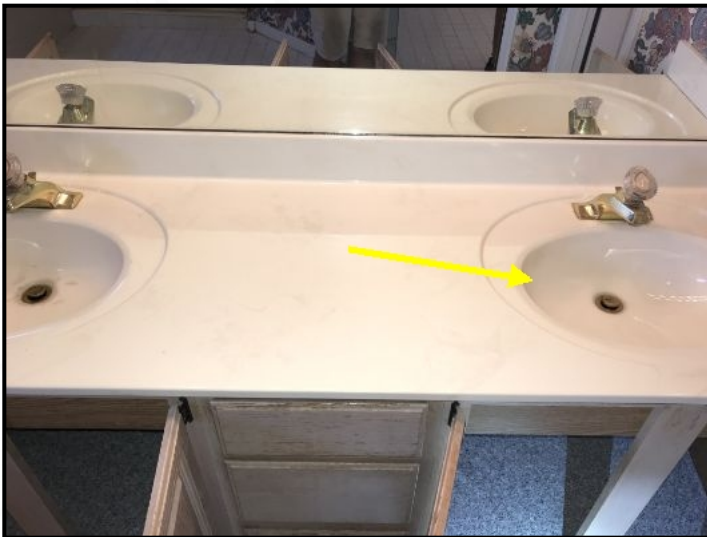
- This bathroom sink was slow to drain. The blockage should be located and cleared by a qualified plumbing contractor.

Sink on the right in the master bath is clogged

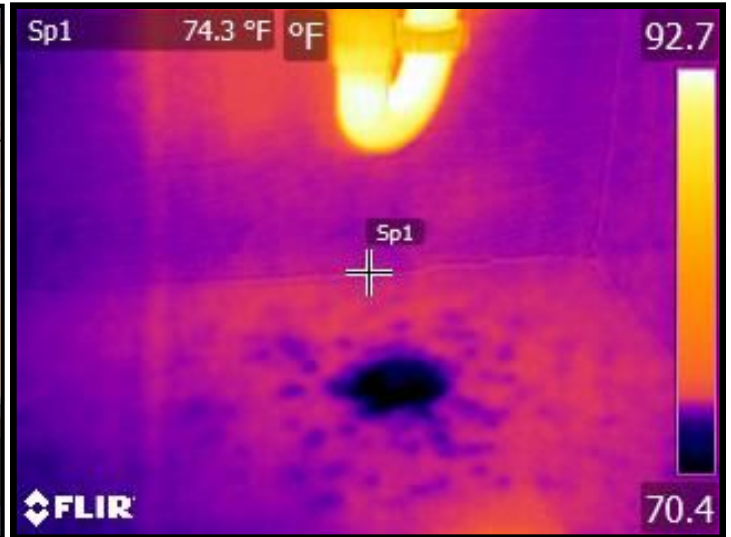
- A faucet supply pipe connection beneath the bathroom sink was leaking at the connection and should be corrected to avoid cabinet damage. The Inspector recommends repair by a qualified plumbing contractor.

There is a leak under the left sink in the master bath.

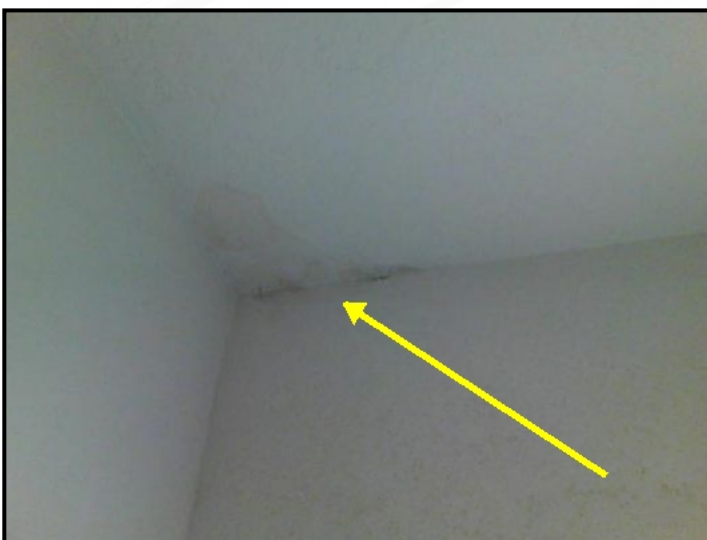
- Stains on the ceiling in this bathroom visible at the time of the inspection appeared to be the result of roof leaks. The moisture meter showed elevated levels of moisture present in the affected areas at the time of the inspection, indicating that the leakage has been recent. The source of leakage should be identified and corrected, and the ceiling re-painted. The Inspector recommends that before the expiration of your Inspection Objection Deadline you consult with a qualified contractors to discuss options and costs for correction and repair.

Stains on the ceiling in the upstairs bathroom

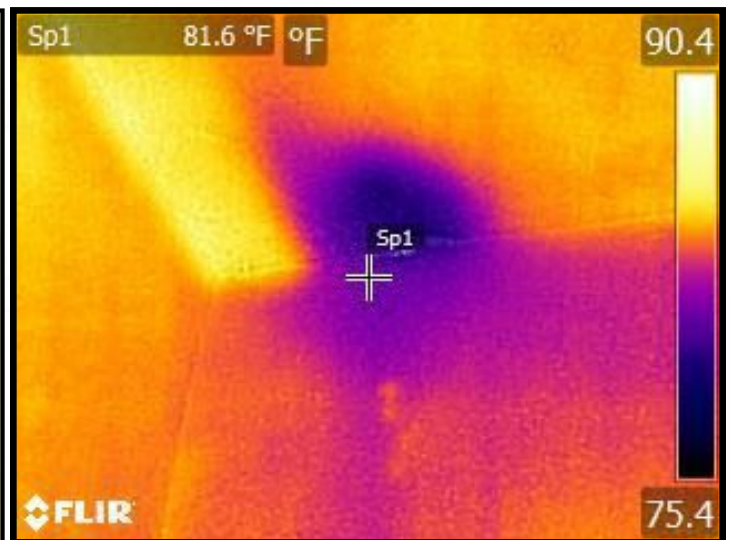
The ceiling in the upstairs bathroom was wet. This is right below the area around the chimney that was leaking
