PROPERTY INSPECTION REPORT

Sample Way, Orlando, FL 32803

DATE OF INSPECTION: 7/7/2019

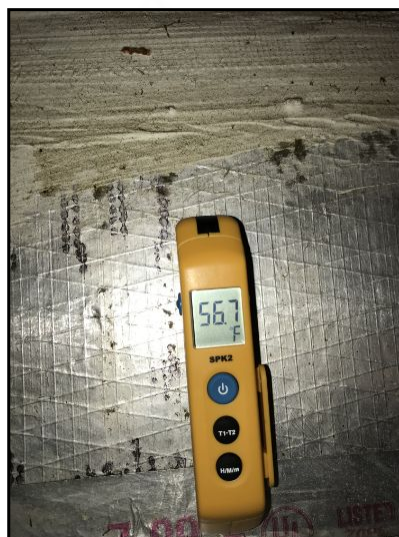
Cooling temperature for the downstairs unit was 56.7 degrees

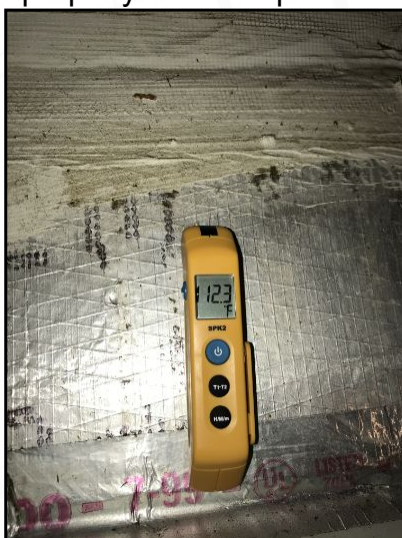
Heating temperature for the downstairs unit was 112.3 degrees.

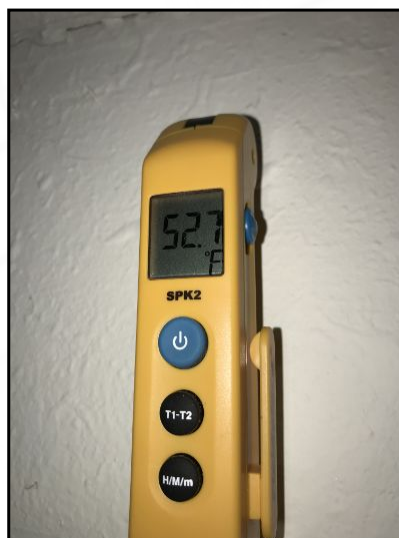
Cooling temperature for the upstairs unit was 52.7 degrees

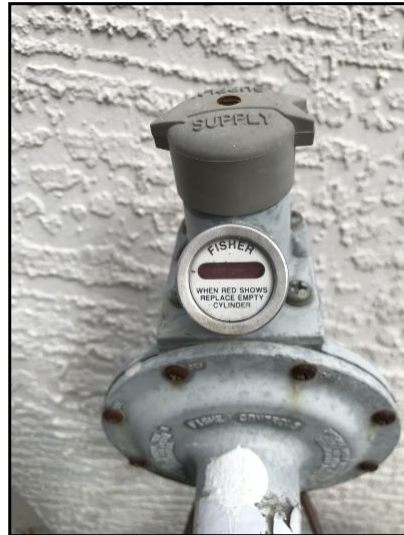
Tanks were empty. Could not test fireplace function because of this.

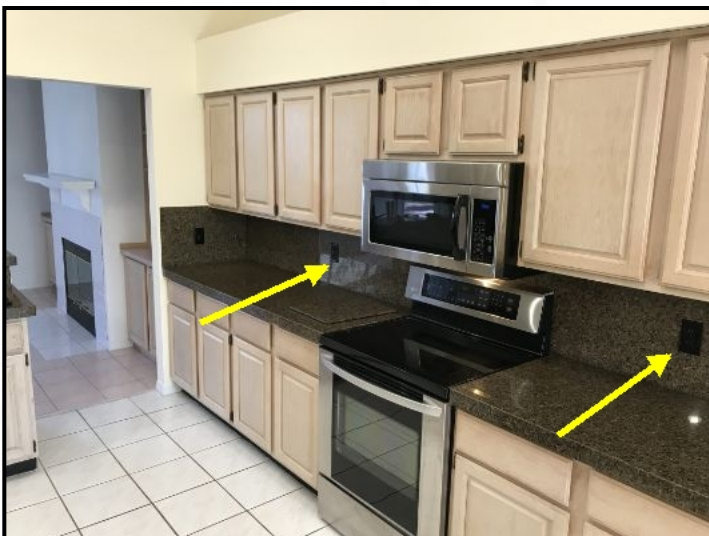
- An electrical receptacle in the kitchen had an open ground. Other receptacles in the home were grounded. This receptacle should have a functional equipment grounding conductor installed by qualified electrical contractor.

These outlets on the right side of the kitchen show an open ground. This should be corrected by a licensed electrician.

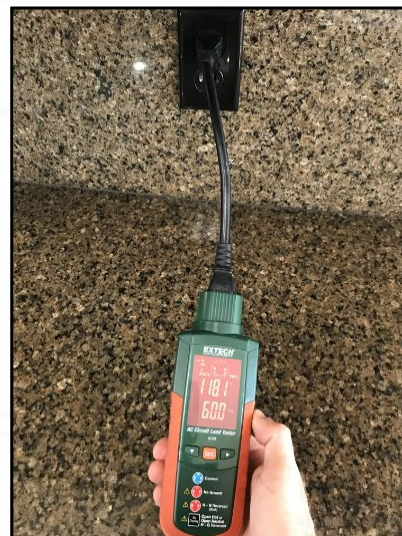
Tester showing open ground outlets
