PROPERTY INSPECTION REPORT

Sample Way, Orlando, FL 32803

DATE OF INSPECTION: 7/7/2019

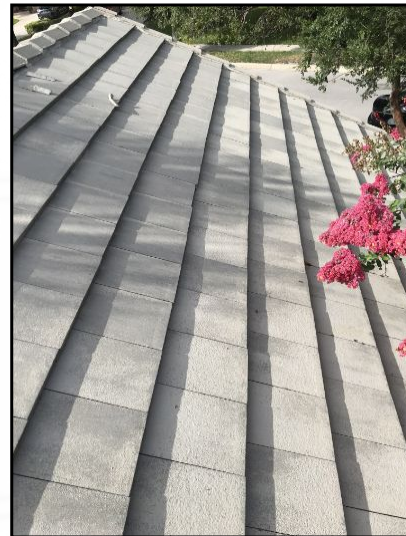
The roof had flat concrete tiles. These are original from when the home was built in 1990

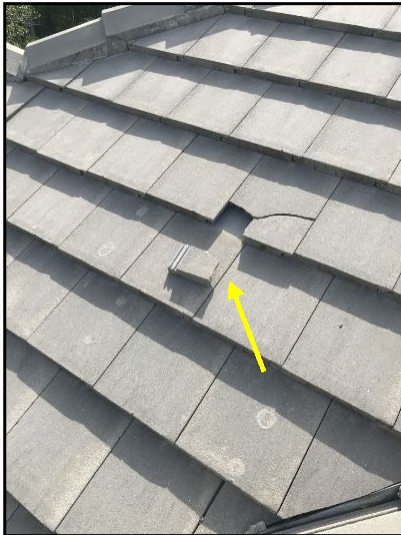
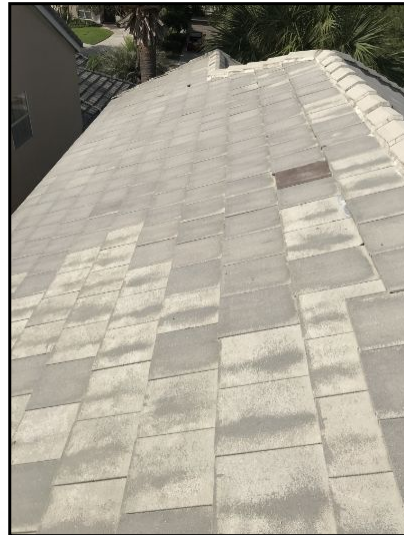
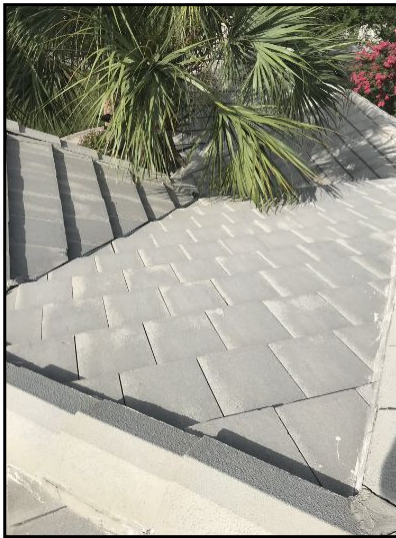
- Headwall flashing exhibited general severe corrosion and was rusted through in places. This condition is likely to allow roof leakage. Headwall flashing in this condition should be replaced immediately to avoid damage from roof leakage. The Inspector recommends that before the expiration of your Inspection Objection Deadline, you consult with a qualified roofing contractor to discuss options and costs for replacement.

Flashing that has rusted through. This needs to be replaced or sealed up.

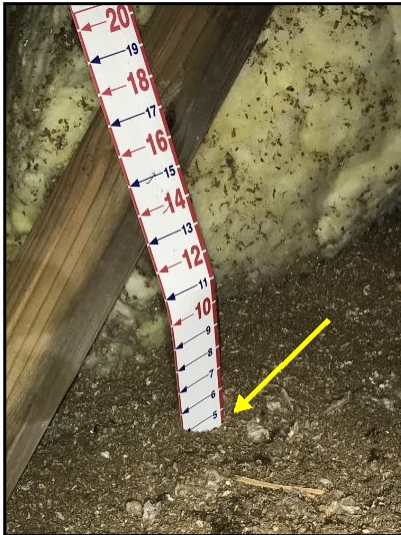
- Thermal insulation installed to limit heat gain and loss in the living space did not appear to meet widely-accepted modern standards. To reduce energy consumption and heating/cooling costs, the inspector recommends that additional thermal insulation be added to meet modern standards. A qualified insulation contractor should be able to advise you capably.

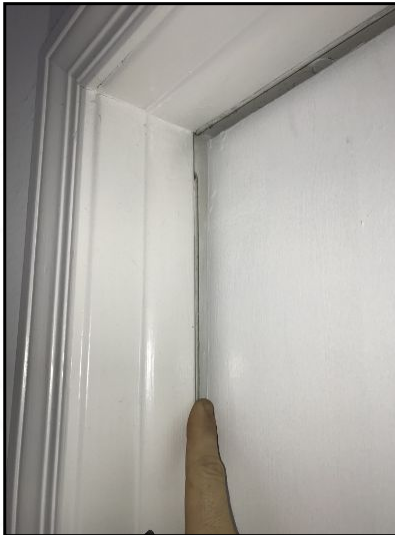
The door to the living space did not seal well against the weather stripping. This can lead to fumes from garage stored chemicals entering the living area. Recommend repair by a qualified handyman.

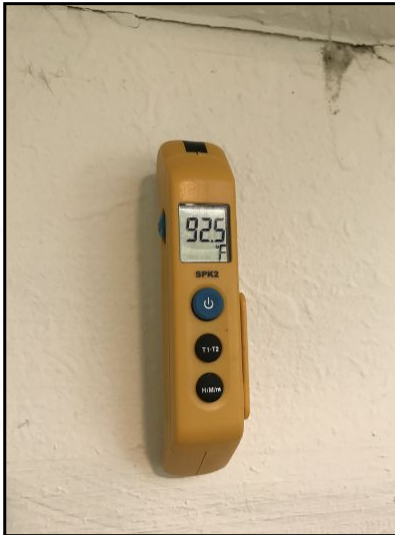
Heating temperature for the upstairs unit was 92.5 degrees.

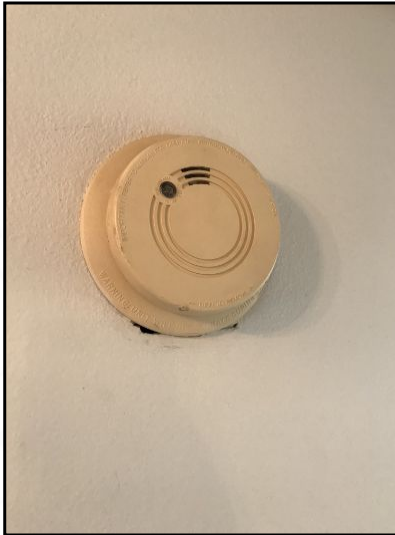
• The smoke detectors protecting sleeping areas were older and may not be functional. Although testing of smoke detectors lies beyond the scope of the General Home Inspection, the Inspector recommends that you have this and any other older smoke detectors tested and maintained, upgraded or replaced as needed. Hardwired smoke detectors should be replaced by a qualified electrical contractor.

Smoke detectors are old and probably original. I recommend replacing all of these

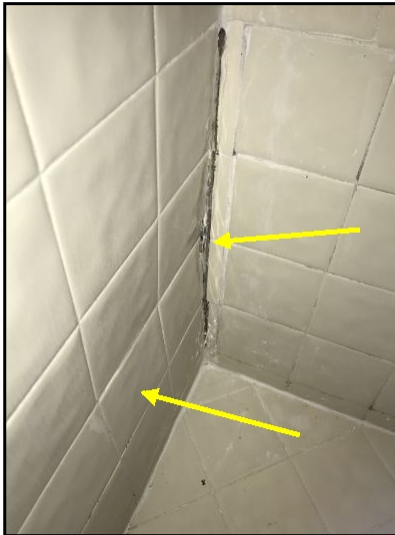
- Shower wall tiles were loose or missing at the time of the inspection.
- The shower tiles had areas of cracked grout that may allow moisture to penetrate the walls. Recommend sealing with silicone caulk

Tiles are caved in in the master bath shower. This is probably from water getting behind the tiles and causing decay on the drywall/cement board. Recommend repair by a qualified handyman.

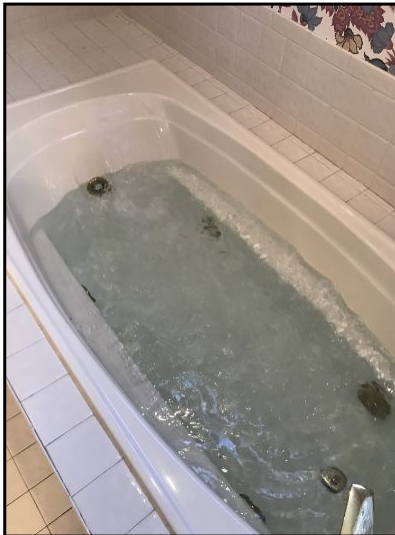
Jetted tub worked properly
